# **AQUATIC PLANT MANAGEMENT PLAN**

**FISH, CRYSTAL and INDIAN LAKES  
Lower Wisconsin River Basin**

**DANE COUNTY, WISCONSIN**

January 2007

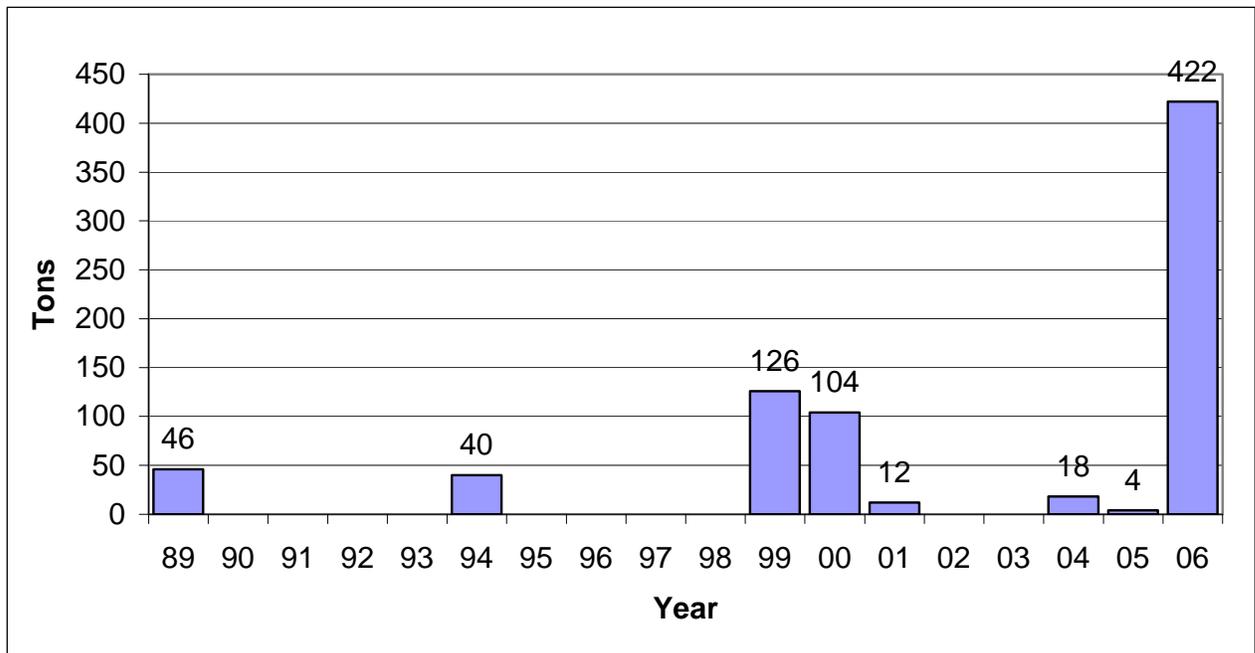
Figure 2: Fish Lake mechanical harvesting summary

The primary focus of mechanical harvesting in Fish Lake is to improve boating access from the Fish Lake Park launch and along developments around the lake. Harvesting records from 1999 through 2004 indicate that plant tonnages removed from the lake ranged from 13 to 104 tons of plants ( 40 tons – 1999, 104 tons – 2000, 13 tons – 2001, 18 tons - 2004). Figure 2 documents Dane County harvesting records since 1989.

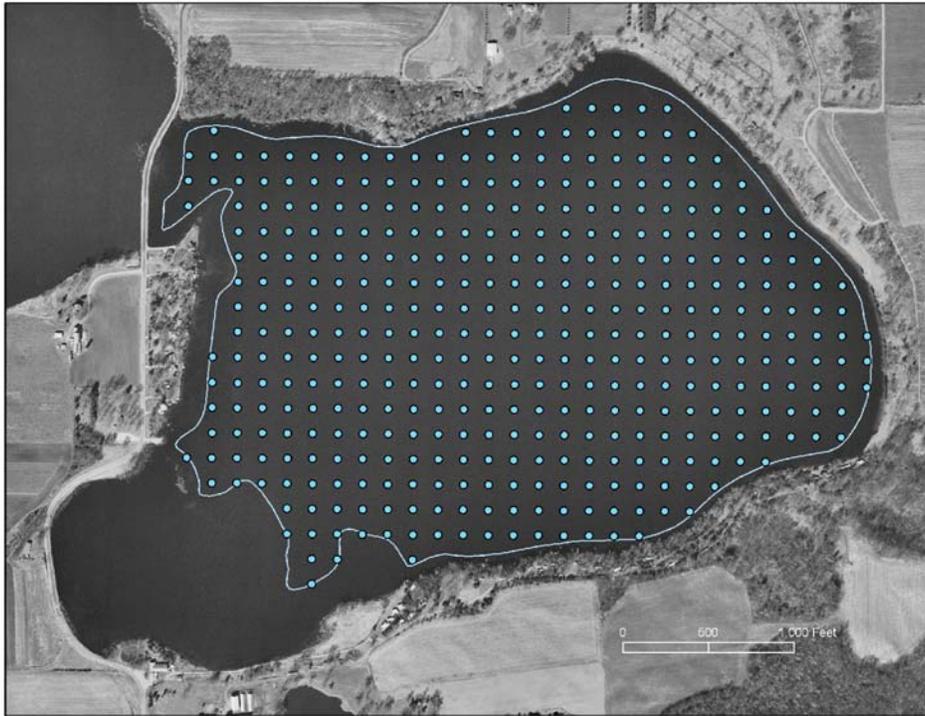
Figure 3: Point intercept sampling grid for Fish Lake

Aquatic plant sampling depths ranged from 5 feet to 36 feet with a mean depth of 14.4 feet. The grid system was created from an older map and did not capture shallow nearshore areas around the lake. The sampling depths in Fish Lake were generally greater than other Dane County lakes sampled for macrophytes in 2006 due to the lack of nearshore sites and presence of moss beyond the littoral zone. Mosses were found to grow within the depth range (17 – 31 feet) typically defined as littoriprofundal (Wetzel 1983). Implications for the range of sampling depths were twofold. First, the minimum depth of 5 feet resulted in under sampling native plants that were located close to shore. Second, sampling moss beyond the typical littoral zone resulted in lower relative and vegetated site frequencies for both EWM and coontail (Figure 4). The results were adjusted in Figure 5 by removing the moss data. Regardless of these sampling issues, EWM and coontail dominated most of the littoral zone and reflected low native species richness beyond 5 feet water depth. Only one other species was found during the point intercept sampling effort. Actual plant distributions across Fish Lake are located on the maps in Appendix D. A single watershield specimen was collected along the west shoreline. The average rake fullness rating was 2 for both EWM and coontail.

The sampling grid provided by DNR (Figure 3) did not include the southwest bay but observations confirmed dominance of EWM and coontail in that area as well. Both species were also dominant in that area when the lake was sampled from 1991-94. Because the sampling grid did not include nearshore areas during the 2006 survey, native plants and herbarium specimens closer to shore were periodically collected and identified. While the additional specimen collections did not constitute a complete nearshore sampling effort, the presence of white water lily, smartweed, clasping-leaf pondweed, floating-leaf pondweed, and sago pondweed were identified at various locations around the lake. Sampling planned for summer 2007 will both expand the point intercept sampling sites within the southwest bay and elsewhere, and include a more thorough survey of nearshore plants. This plan will then be amended to incorporate those results.

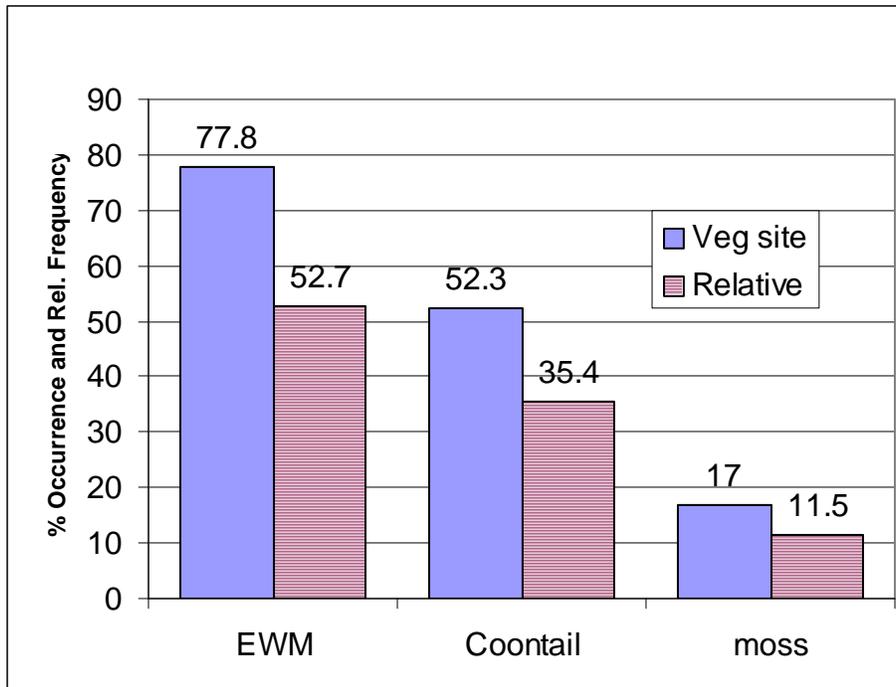
Figure 4: Fish Lake vegetated site occurrence and relative frequency results

The relative frequency describes the percentage that each aquatic plant species contributes to the whole aquatic plant community. Relative frequency is a commonly used metric since survey results can be compared with surveys that used different sampling techniques.

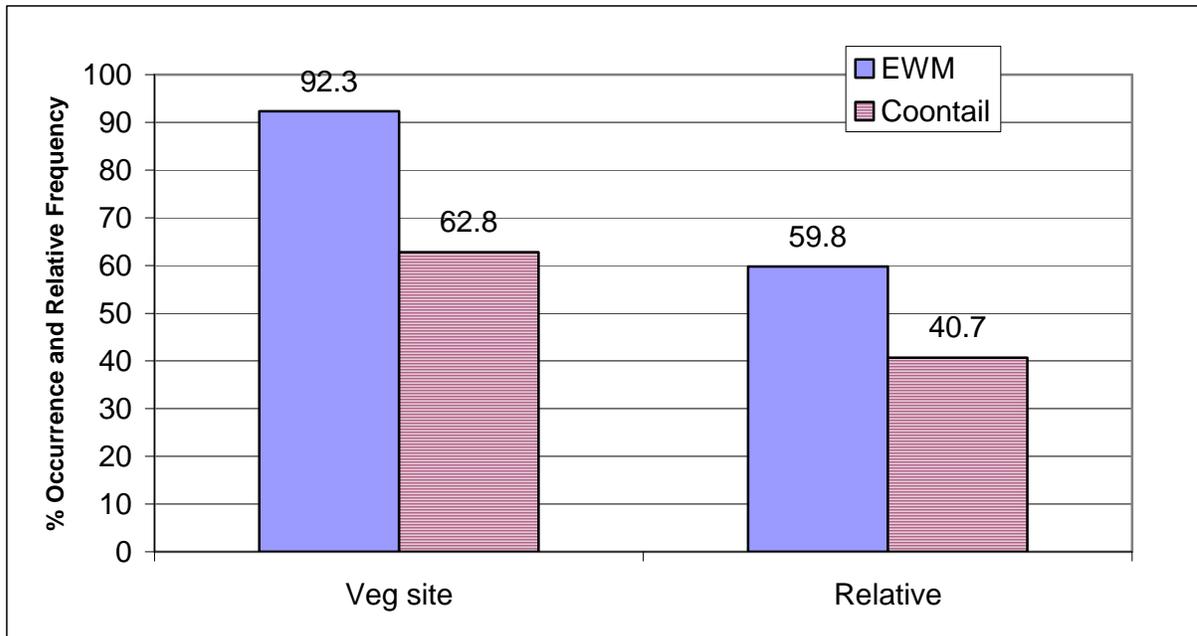
Figure 5: Fish Lake vegetated site occurrence and relative frequencies without moss

The relative frequency describes the percentage that each aquatic plant species contributes to the whole aquatic plant community. Relative frequency is a commonly used metric since survey results can be compared with surveys that used different sampling techniques.

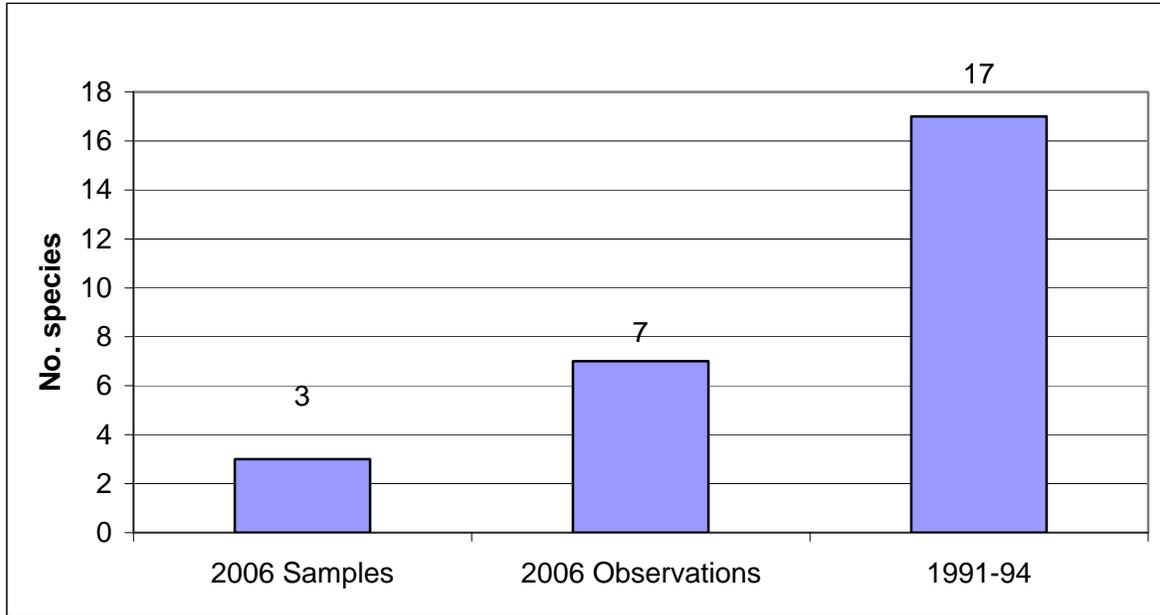
Figure 6: Fish Lake native species richness – 2006 survey, 2006 observations, and 1991-94 surveys

American lotus was observed growing in abundance around adjoining Mud Lake. No evidence was found of American lotus in Fish Lake including the Lussier Park area where it was planted in 2002 as part of a habitat restoration effort. Several species including American lotus, white water lily, smartweed, clasping-leaf pondweed, and sago pondweed were found desiccated within the drawdown zone of both Fish and Mud Lakes. In addition to the nearshore native plant observations, a few curly-leaf pondweed (CLP) turions were observed floating, an indication that the plant was in the over-wintering stage during the survey.

Native species richness was greater during the more intensive macrophyte surveys from 1991-94, perhaps reflecting different sampling methodologies and more intensive nearshore sampling at that time. Figure 6 compares native species richness data for the 2006 point intercept sampling effort, 2006 combined sampling with observations, and 1991-94 surveys results. Additional nearshore sampling is required to determine if a decline in native species richness has occurred. Aside from these differences, the general pattern of EWM dominating throughout the deeper portion of the littoral zone did not change. Coontail was the second most abundant plant during all of the surveys.

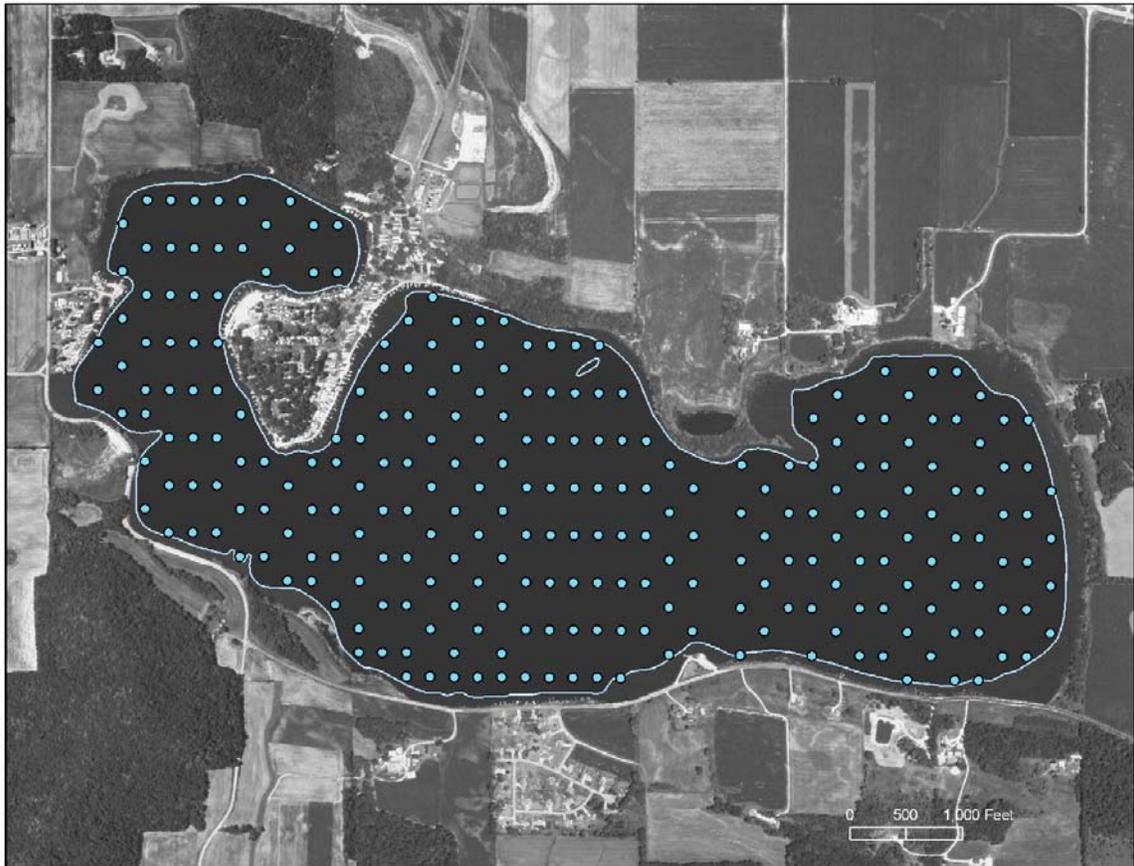
Figure 8: Point intercept sampling grid for Crystal Lake

Consistent with the Fish Lake sampling grid, most of the sampling points were not very close to shore since the maps did not reflect the current lake volumes. For instance, in the Figure 8 grid sampling provided by DNR, a portion of the northeast bay was excluded. Historically, that area was partly a cattail marsh. Collection of specimens closer to shore was attempted, however nearshore native species richness did not appear to differ from deeper locations and the only additional plants observed were white water lily and cattail (*Typha*). Overall, the sampling grid did not significantly affect the plant native species richness score. Sampling planned for summer 2007 will capture areas excluded in 2006, and this plan will then be amended to incorporate those results.

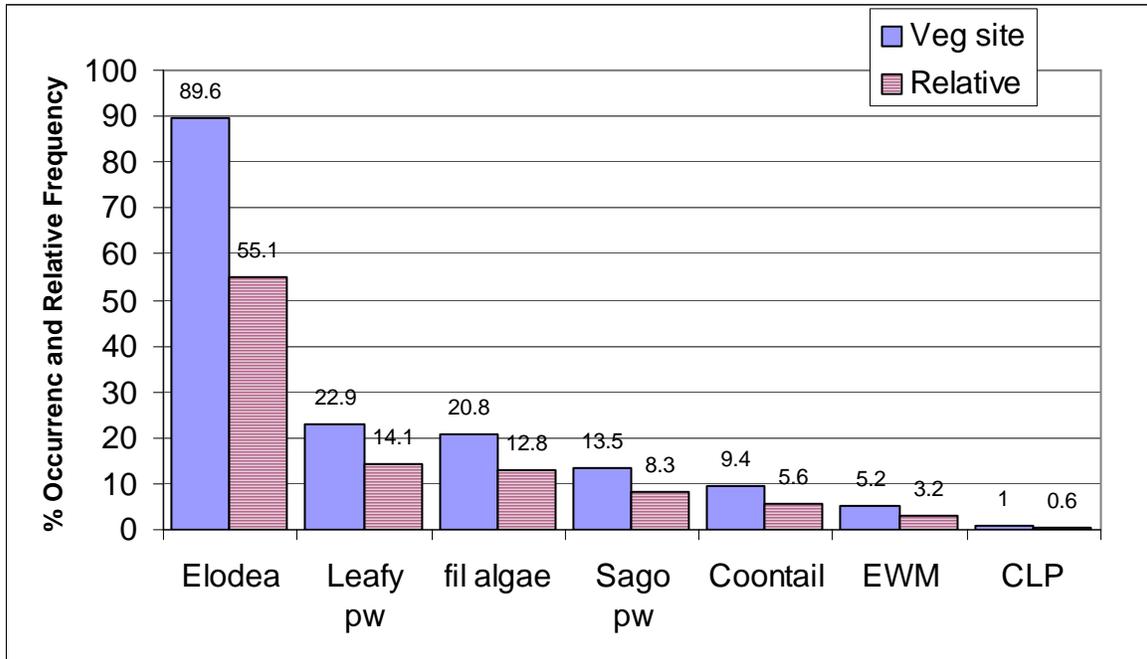
Figure 9: Crystal Lake vegetated site occurrence and relative frequency results

Unlike Fish Lake, where EWM is clearly the dominant macrophyte, native species are dominant in Crystal Lake. Common waterweed (*Elodea canadensis*) is the most abundant plant followed by leafy pondweed (*Potamogeton foliosus*). Filamentous algal growths are also relatively abundant in the lake and are often attached to the aquatic plants. Both the vegetated sites frequency and relative frequency results reflect the dominance of common waterweed in Crystal Lake (Figure 9). Results also indicate that EWM was infrequently found in 2006 and it did not pose recreational or ecological problems. The average rake fullness was 1 for EWM and 2 for common waterweed, coontail and sago pondweed. Native species richness was actually higher in Fish Lake if the nearshore plants that were not part of the point intercept sampling effort are included. Appendix E notes fish and wildlife values of desirable native plant species in Fish, Crystal and Indian lakes. Distributions of the plants found in Crystal Lake are displayed in Appendix F.

The relative frequency describes the percentage that each aquatic plant species contributes to the whole aquatic plant community. Relative frequency is a commonly used metric since survey results can be compared with surveys that used different sampling techniques.

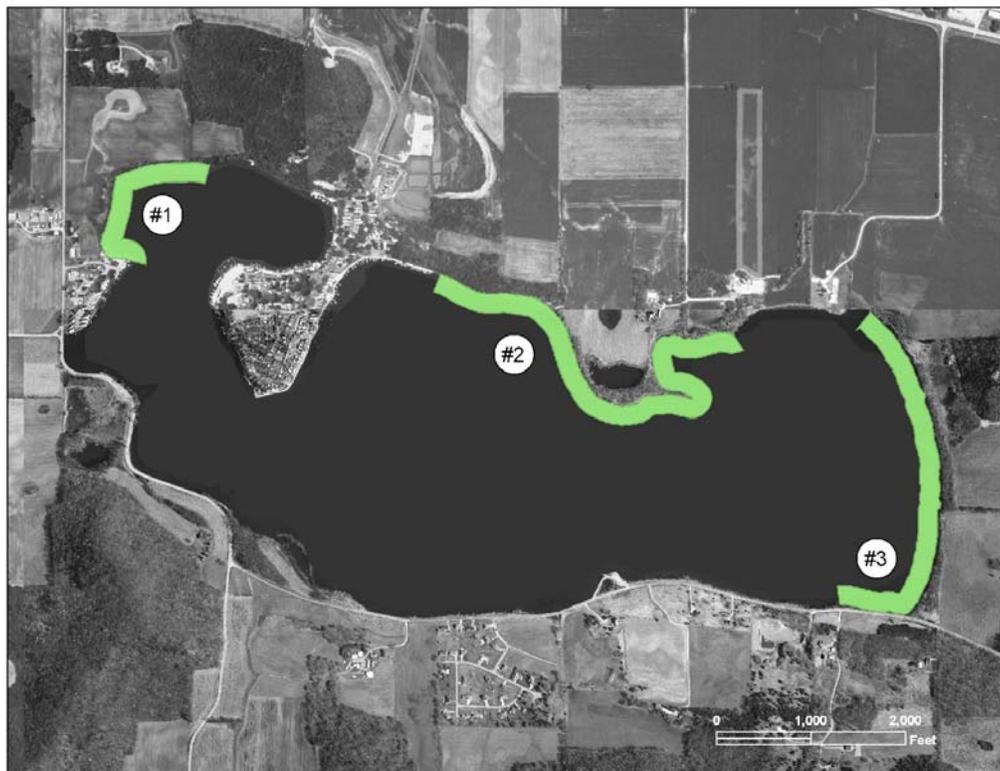
Figure 10: Proposed Crystal Lake sensitive areas

Sensitive Areas have not been designated on Crystal Lake. Based on the 2006 survey results, Sensitive Areas should include portions of the northeast bay and west shoreline (Figure 10) that support white water lilies. Chemical treatments and large-scale mechanical harvesting should be avoided in these areas.

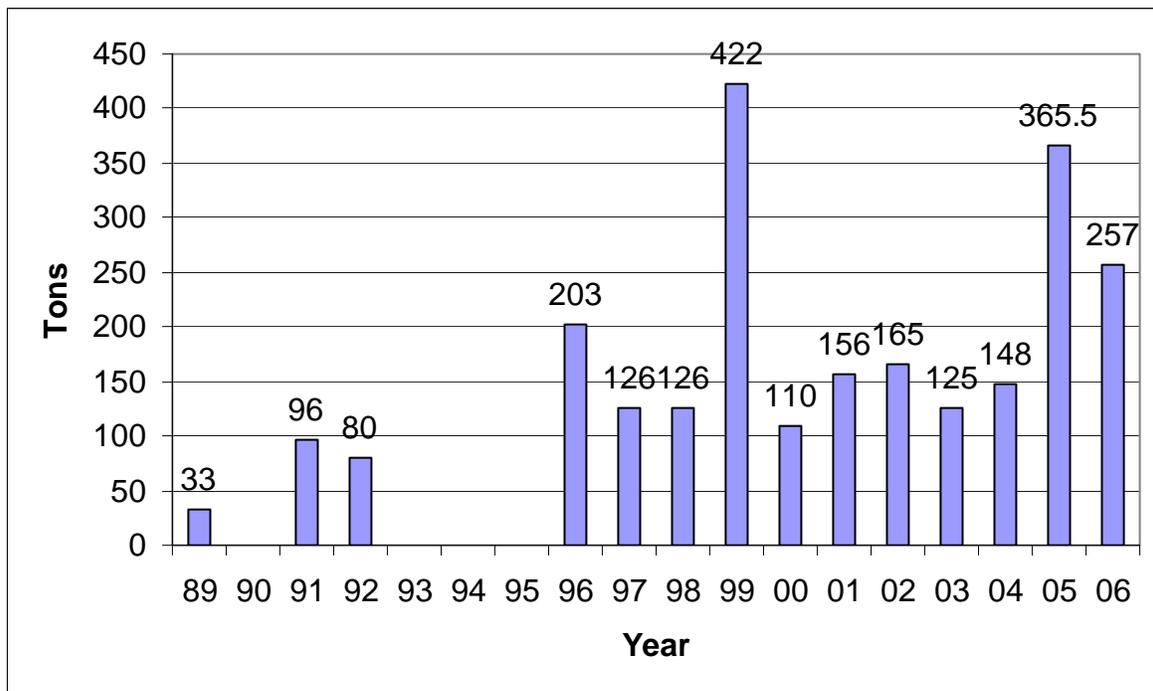
Figure 11: Indian Lake mechanical harvesting summary

Dane County records indicate that Indian Lake has been harvested since 1998. The primary goal is to create navigation channels within dense plant beds from the public boat ramp to various access points across the lake. Figure 11 displays annual tonnages of harvested aquatic plants removed from Indian Lake from 1989 to 2006, and Figure 12 shows Dane County harvesting priorities at Indian Lake.

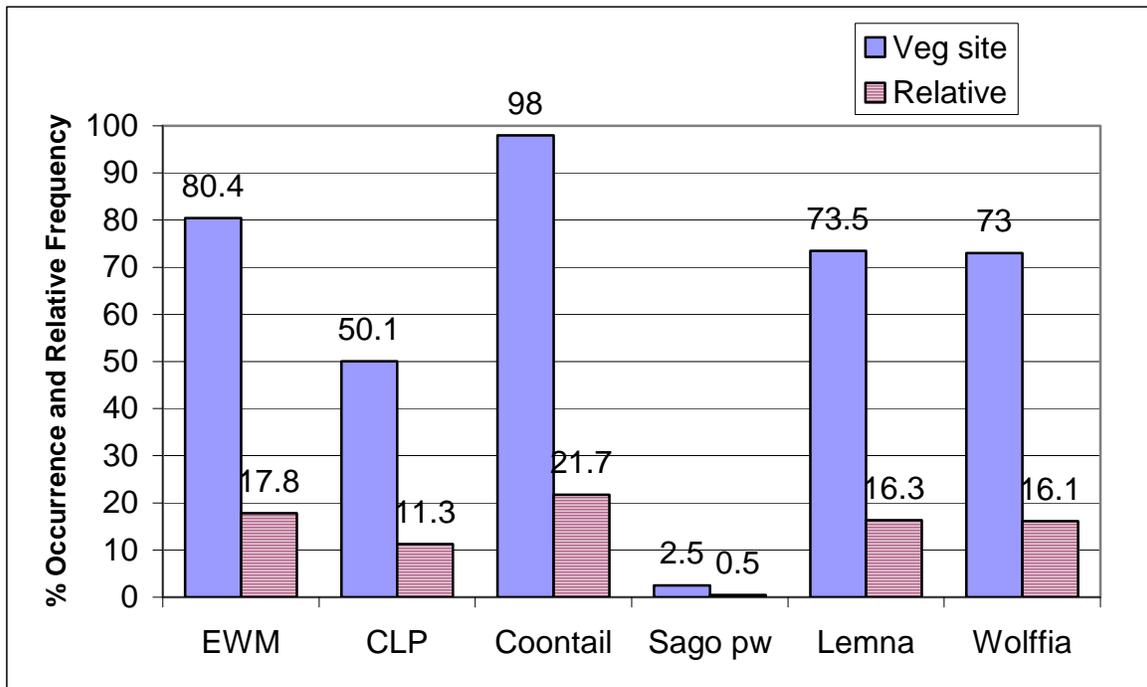
Figure 14: Indian Lake vegetated site occurrence and relative frequency results

floating plants are displayed in Figure 14. The average rake fullness was 2 for EWM and 3 for coontail. Beyond the sampling points, the entire lake was bordered by emergent vegetation, mostly cattails and to lesser extent bur reeds. Aquatic plant distributions are displayed in the Appendix G maps for the individual species. Appendix E notes fish and waterfowl values of desirable native plants in Fish, Crystal and Indian Lakes.

The relative frequency describes the percentage that each aquatic plant species contributes to the whole aquatic plant community. Relative frequency is a commonly used metric since survey results can be compared with surveys that used different sampling techniques.
