# AQUATIC PLANT MANAGEMENT PLAN

JENNI AND KYLE PRESERVE PONDS

**November 2007**

**Underwater Habitat Investigations, LLC**  
(Dave Marshall)

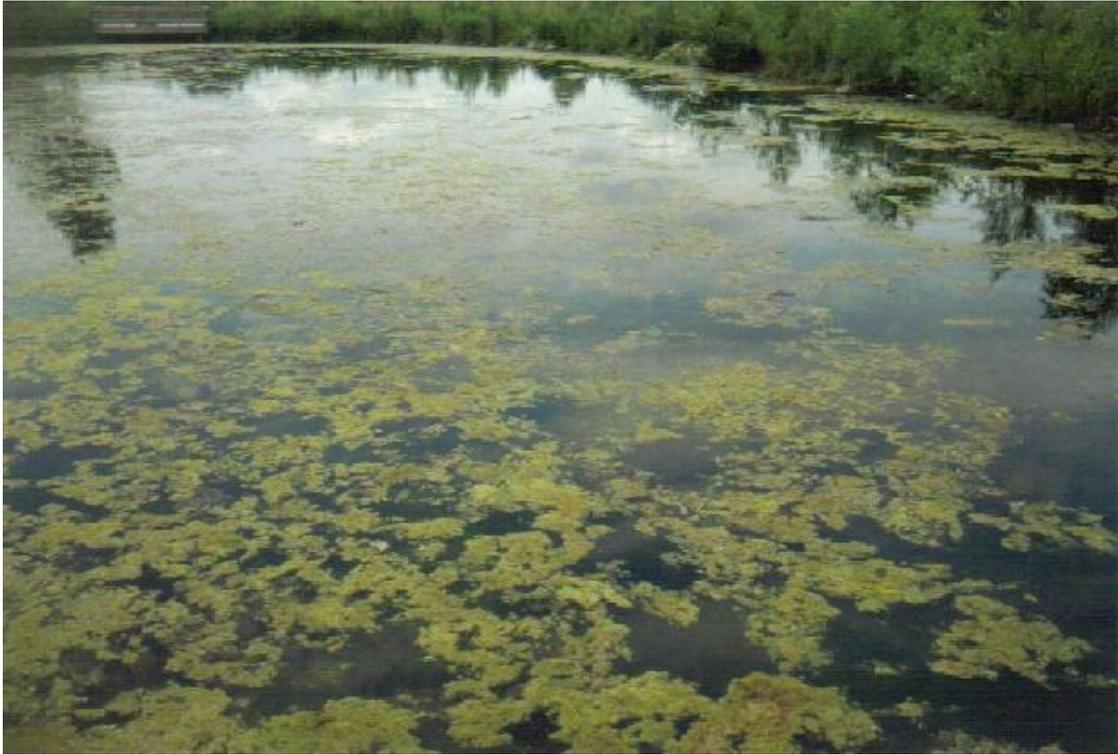
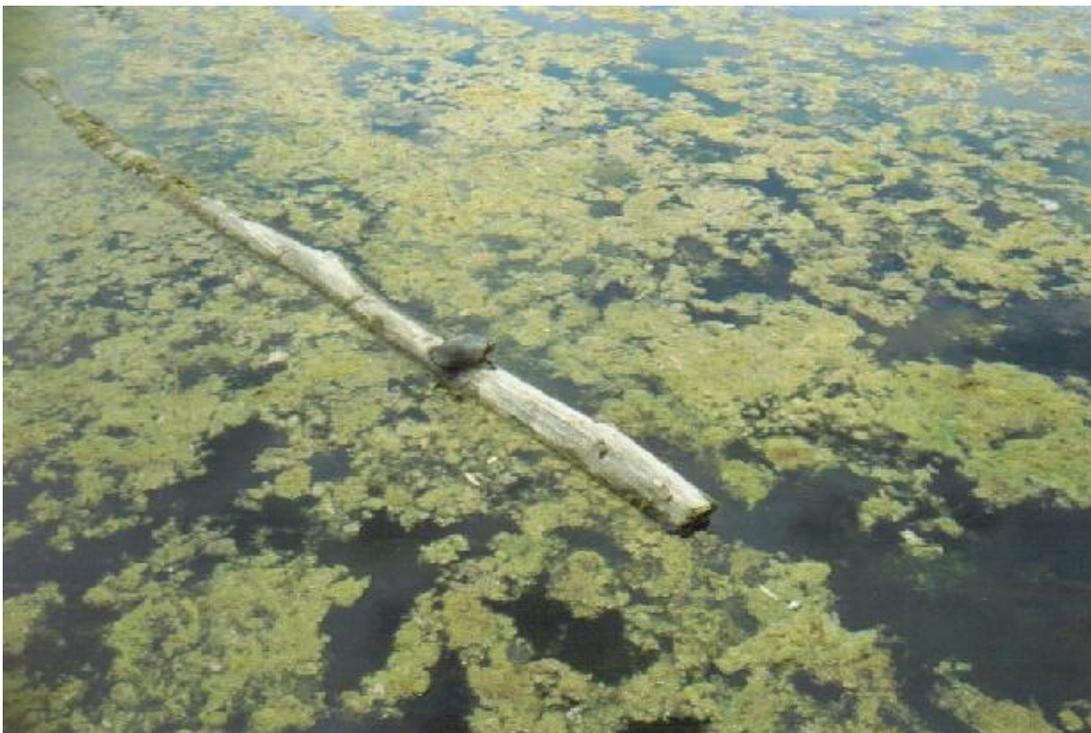
The second survey was performed on June 28<sup>th</sup>. Filamentous algal growth was significantly greater in both ponds, rendering them un-fishable for shoreline anglers (Photos 1 and 2). Rooted plant growth in the larger pond had expanded as well.

Mechanical removal of aquatic plants and filamentous algae in the ponds has improved both public access and fish habitat. Moving mechanical harvesters into the ponds is somewhat challenging given the small surface areas. The riparian vegetation is not high quality and therefore not subject to damage while accessing the ponds. Manual methods of aquatic plant control may be more appropriate for the small pond. Efforts to increase turtle habitat have been successful by adding coarse woody debris (logs). Consideration should be given to improving mechanical harvester access to the ponds and continue sustaining turtle habitat.

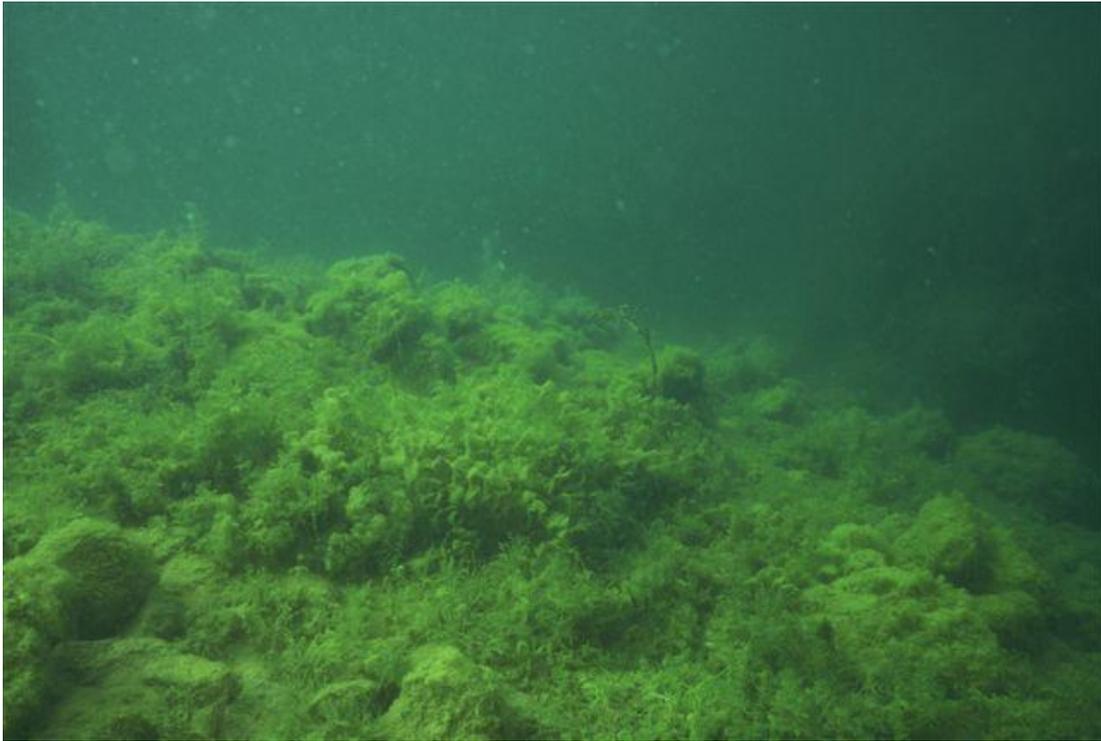
Photo 3 (rock bar with low growing Chara and naiad)

Verona Quarry/Swimming Beach was inspected on June 22<sup>nd</sup> and again on July 2, 2007. The June inspection entailed a shoreline inventory of aquatic plants but due to the large surface area a boat survey was also performed in July. The crystal clear water in the quarry supports slender naiad (*Najas flexilis*) and muskgrass (*Chara*) on rocky substrates. In the deeper portions, EWM was dominant based on both surface observation and a SCUBA survey performed in July. Other species observed included sago pondweed, leafy pondweed, common waterweed, CLP and an unidentified nearshore floating-leaf pondweed, possibly long-leaf pondweed (*Potamogeton nodosus*). Coarse woody habitat was evident around parts of the pond. Fish species observed during the SCUBA survey included largemouth bass, bluegill, green sunfish and a single large carp. Minnows were observed near shore. Figure 3 is a temperature – dissolved oxygen profile from the deep hole at 20-foot water depth. Adequate dissolved oxygen was found at all depths and the quarry was not thermally stratified. Water was very clear with the Secchi reading greater than the maximum depth (>20 feet). Photos 3 through 5 demonstrate the underwater habitat in the clear water. EWM grows at the maximum depth of 20 feet. Photo 6 demonstrates recent harvesting in about 8 feet of water.

Mechanical harvesting of EWM benefits both fish habitat and angler access in the lake. Anglers were observed fishing both from the two piers and from watercraft. Planting floating leaf plants such as white water lilies or spatterdock may improve habitat in the nearshore areas. Maintaining the wooded areas and associated fallen trees will continue to provide valuable habitat for fish and herptiles.

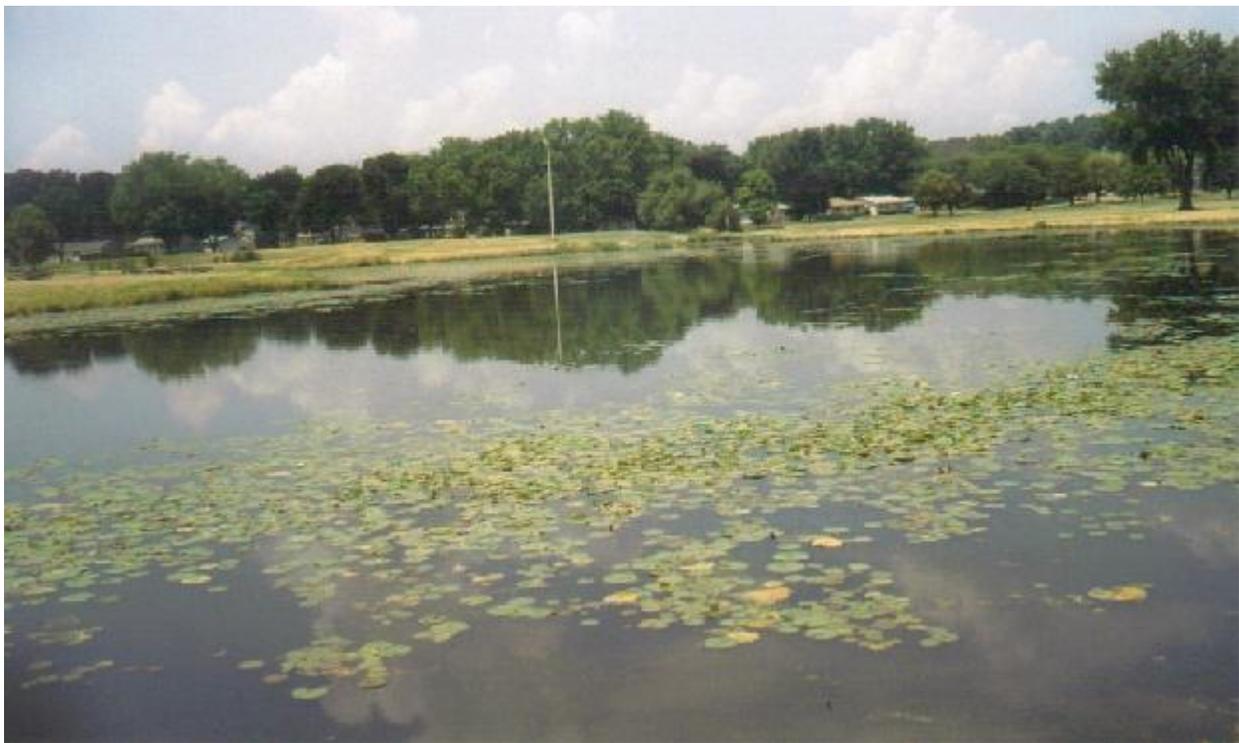
due to the high turbidity. Pockets of white water lilies provided favorable habitat but were not overly abundant. The island provided substantial woody habitat and the south part of the lagoon appeared to be in a more natural state. A few people swam with their dogs in the south lagoon. The north shoreline of the lagoon is mowed to the water and goose droppings covered much of the nearshore lawn.

Figure 5 demonstrates that dissolved oxygen levels were low during the July survey, probably due to dense phytoplankton. Figure 6 is the park lagoon layout. Photo 8 captures one of the numerous pockets of white water lilies.

Mechanical harvesting was not recommended in 2007 since submersed aquatic plants were scarce and white water lilies were providing beneficial habitat functions. Harvesting may be needed in future years if the eutrophic pond shifts to submersed macrophyte dominated, particularly EWM.
